PREWITT AND ASSOCIATES INC AUSTIN TX

**A PRELIMINARY ASSESSMENT of the CULTURAL RESOURCES in
the BRAZOS NATURAL SALT POLLUTION CONTROL PROJECT,
KENT, KING and STONEWALL COUNTIES, TEXAS**

REPORTS OF INVESTIGATIONS, NUMBER 18

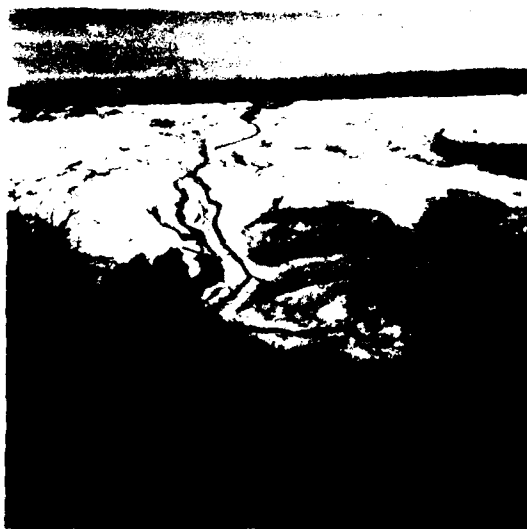
Figure 12

Figure 12. Aboriginal Sites and Localities.

d. View facing north up a spring-fed tributary of North Croton Creek in the western Dam Site 19 area, on the boundary between Survey Units B-75 and B-76. The water in the pool is slightly gypsiferous but relatively fresh. Crayfish were observed in the pool. Note the cat-tails in the foreground. Sites 41KG51 and 41KG52 are immediately adjacent on bedrock benches overlooking the stream.

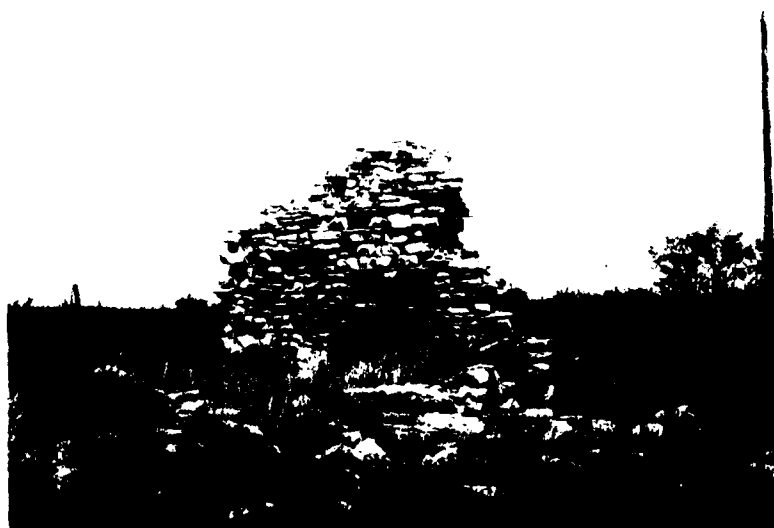
Figure 36

b. Despite its abundance in the Croton Breaks, stone was rarely used in dwellings. An exception is site 41KT22, the McLain House, which was also built in the 1920s. A view from the south illustrates a standing chimney and the only relatively intact wall of what was once a one-room house with a wood frame porch on the east side.
